RM No. E6L10

RESEARCH MEMORANDUM

THE EFFECT OF PREIGNITION ON CYLINDER TEMPERATURES

PRESSESURES, POWER OUTPUT, AND PISTON FAILURES

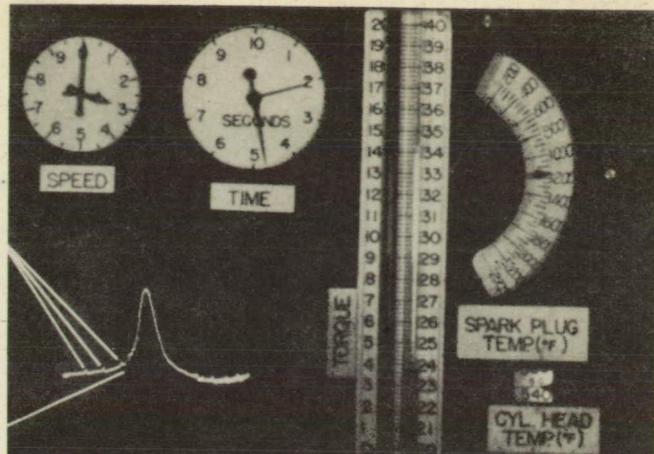
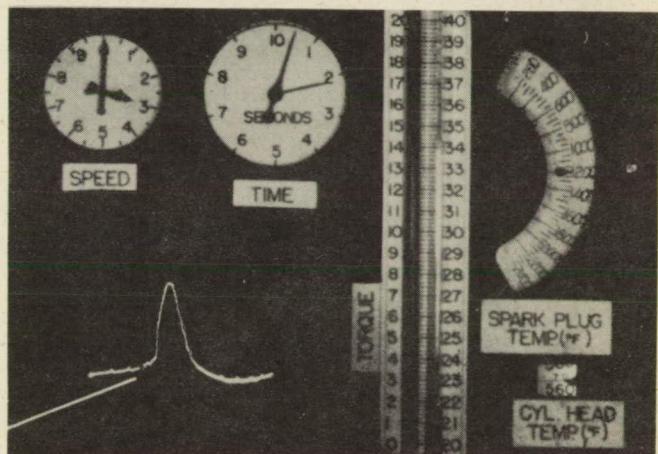
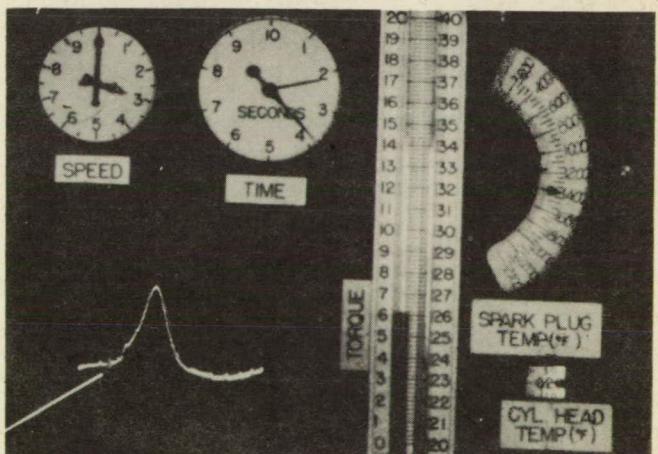
Fig. 3

Figure 3. - Prints made from motion-picture film of preignition test showing instruments photographed during preignition. Time of ignition determined from ionization-gap trace and timing marks on pressure-time diagram.

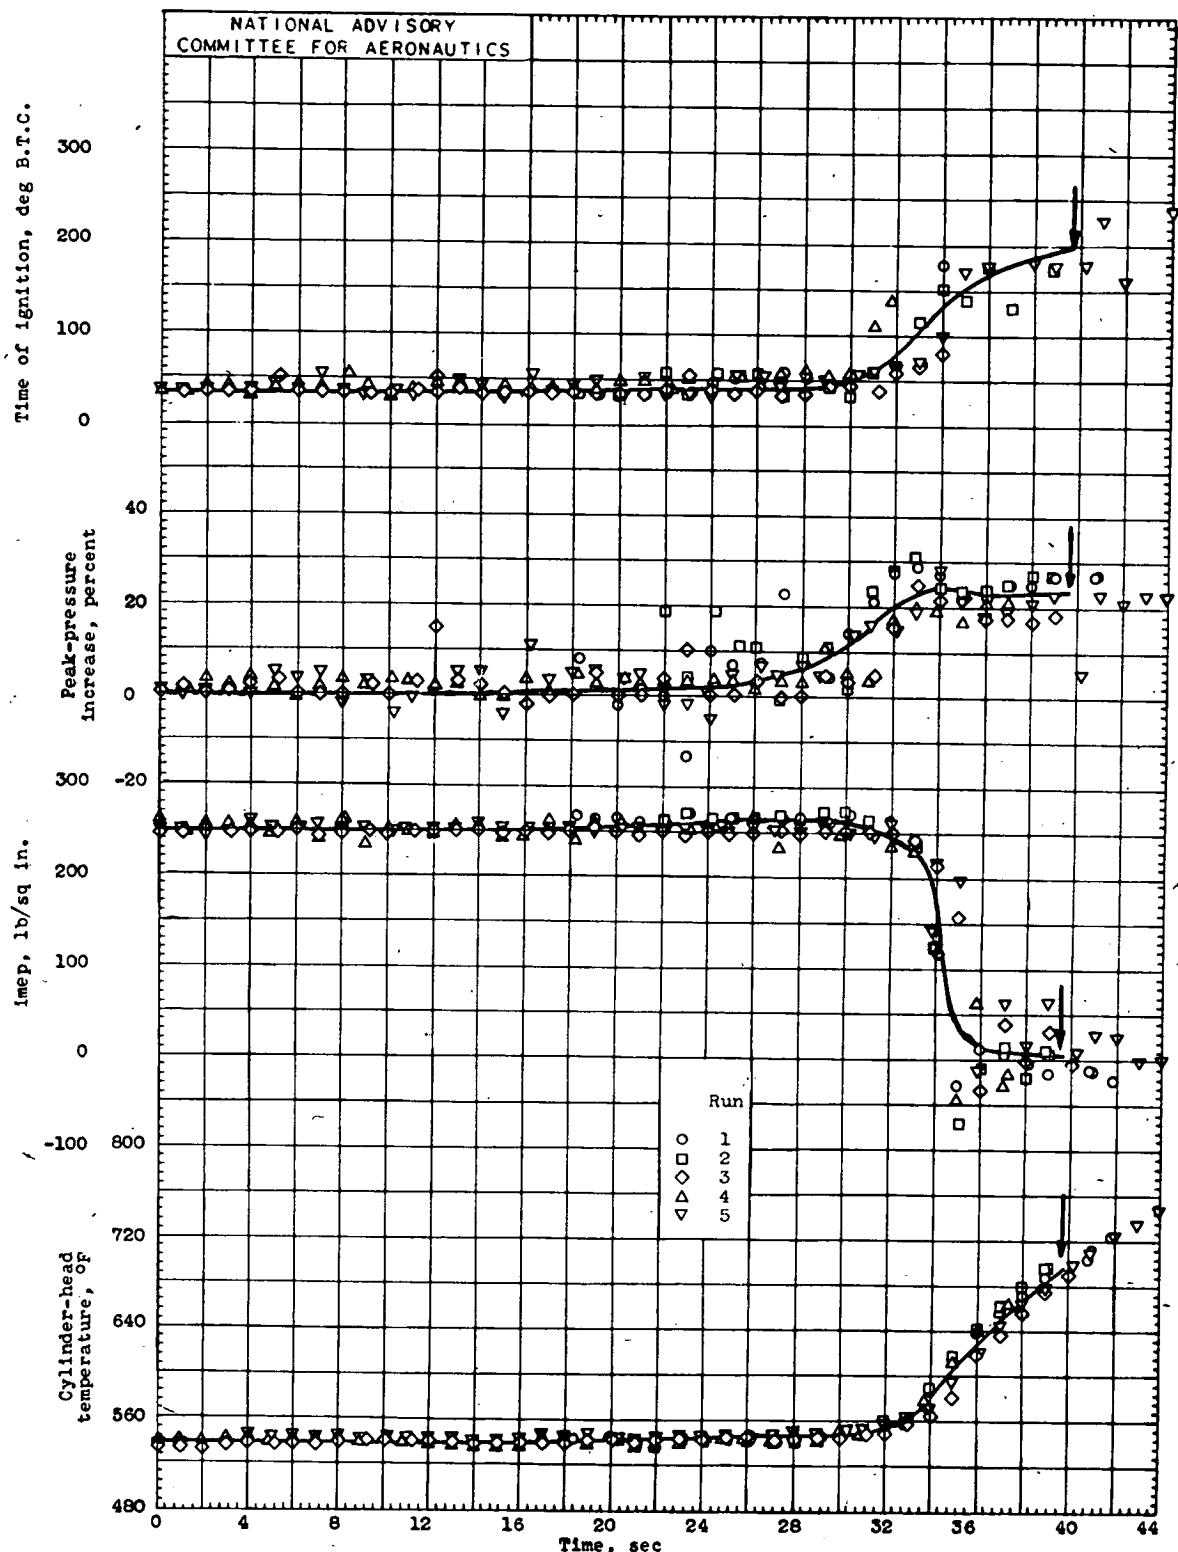
Typical preignition runs. - A plot of five preignition runs at approximately the same operating conditions is shown in figure 4. The time scale used is arbitrary; the curves were so adjusted along the scale that the points where preignition became rapidly accelerated (time of ignition about 60° B.T.C.) coincided. Comparisons between the curves are made easier in this manner by eliminating the consideration of the period of poor reproducibility. The location of the zero point on the time scale therefore has no significance. Figure 4, then, shows the reproducibility of the preignition runs after preignition had begun to advance rapidly.

The curves shown in figure 4 have been faired to represent an average of the individual runs and are considered to be typical of the behavior of the engine during preignition at the given set of operating conditions. All the curves presented have been obtained in this manner from several runs at each operating condition. For the sake of simplicity only the original data are shown in figure 4.

Figure 4. - Typical preignition plot showing scatter of data of five runs at approximately same engine conditions. Engine speed, 3000 rpm; spark advance: inlet, 28° B.T.C.; exhaust, 34° B.T.C.; compression ratio, 6.65; outlet-coolant temperature, 250° F; mixture temperature, 175° F; inlet-oil temperature, 185° F; fuel-air ratio, 0.070; fuel, 30-percent cumene blend; source of preignition, spark plug in exhaust side. (Arrows indicate time of backfire.)

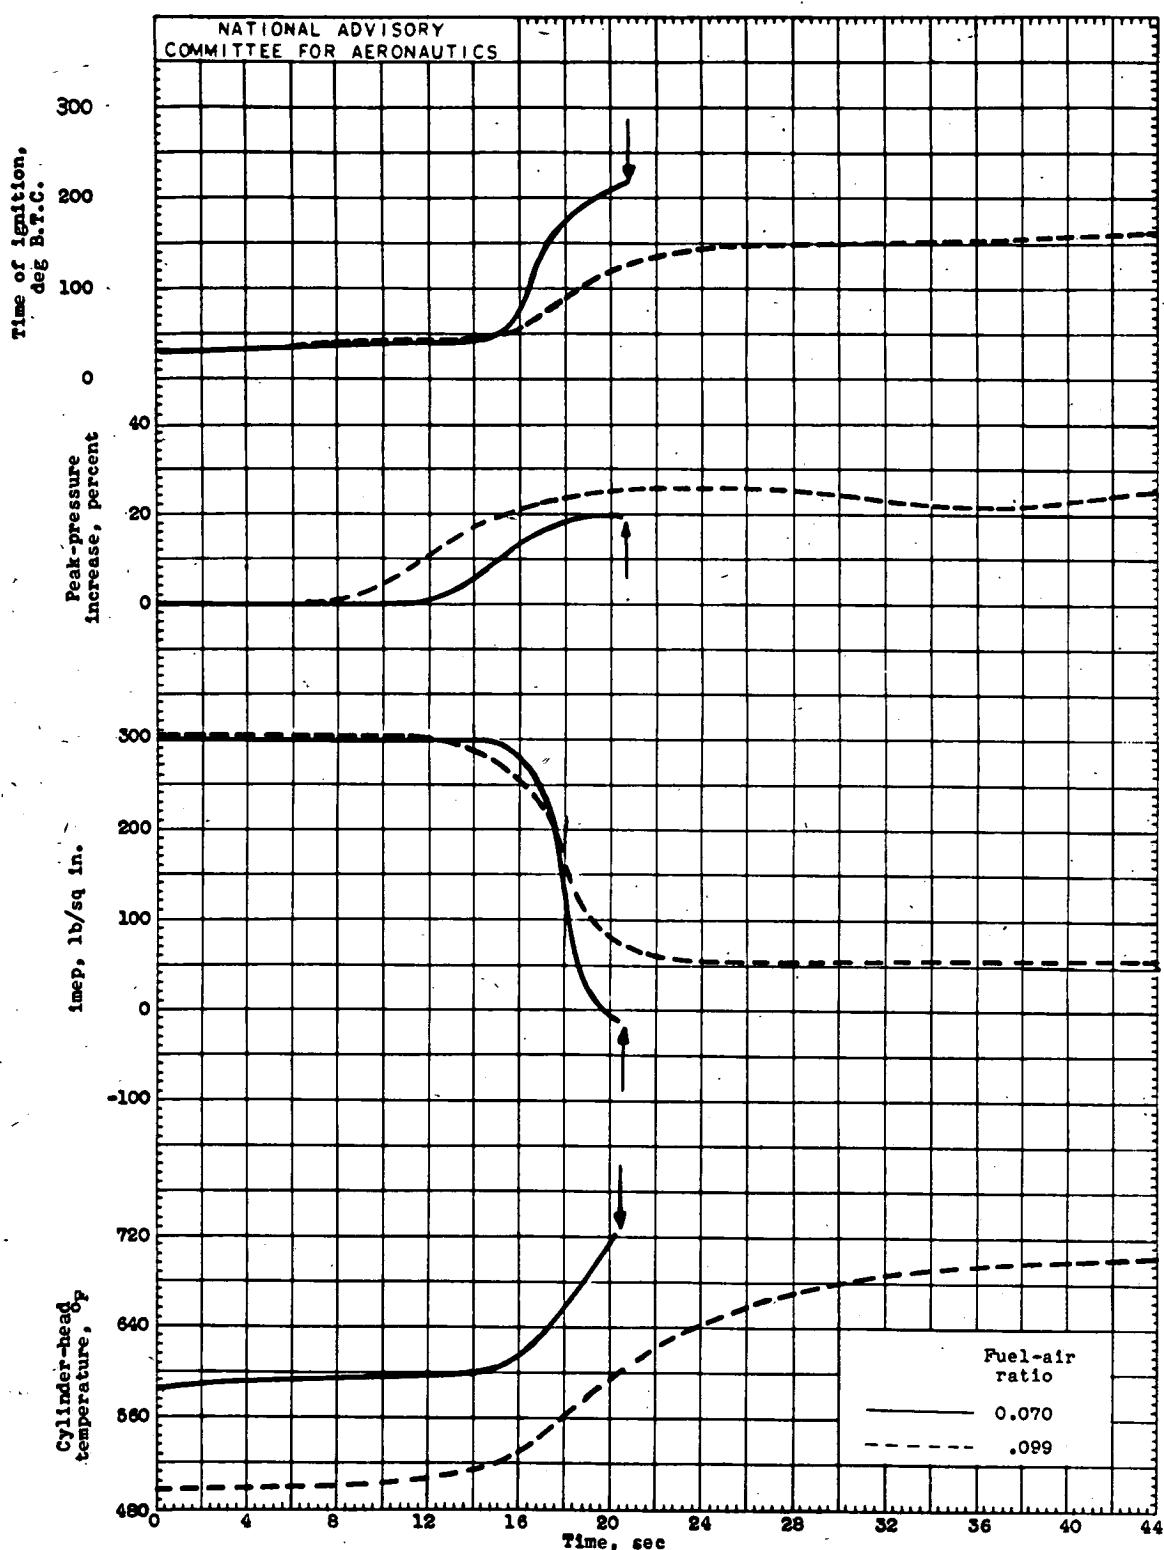
Effect of fuel-air ratio. - Combustion temperatures and rate of burning are controlled by several variables of which one of the most important is fuel-air ratio. Because the behavior of an engine during preignition operation depends largely on these two factors, fuel-air ratio is an important variable in a consideration of preignition. Figure 5 shows typical preignition curves for a lean and a rich mixture at the same power level. At the lean mixture a period of about 7 seconds was required from the time rapidly advancing preignition began until backfiring was encountered. At this point the time of ignition had advanced to about 220° B.T.C. (40° B.B.C.). At the rich mixture, however, the time of ignition did not advance so rapidly and became more or less stable at 150° to 160° B.T.C. The engine did not backfire at the rich mixture.

Figure 5. - Effect of fuel-air ratio on behavior of engine when preignition is encountered. Engine speed, 3000 rpm; spark advance: inlet, 28° B.T.C.; exhaust, 34° B.T.C.; compression ratio, 6.65; outlet-coolant temperature, 250° F; mixture temperature, 175° F; inlet-oil temperature, 185° F; fuel, 30-percent cumene blend; source of preignition, spark plug in exhaust side. (Arrows indicate time of backfire.)

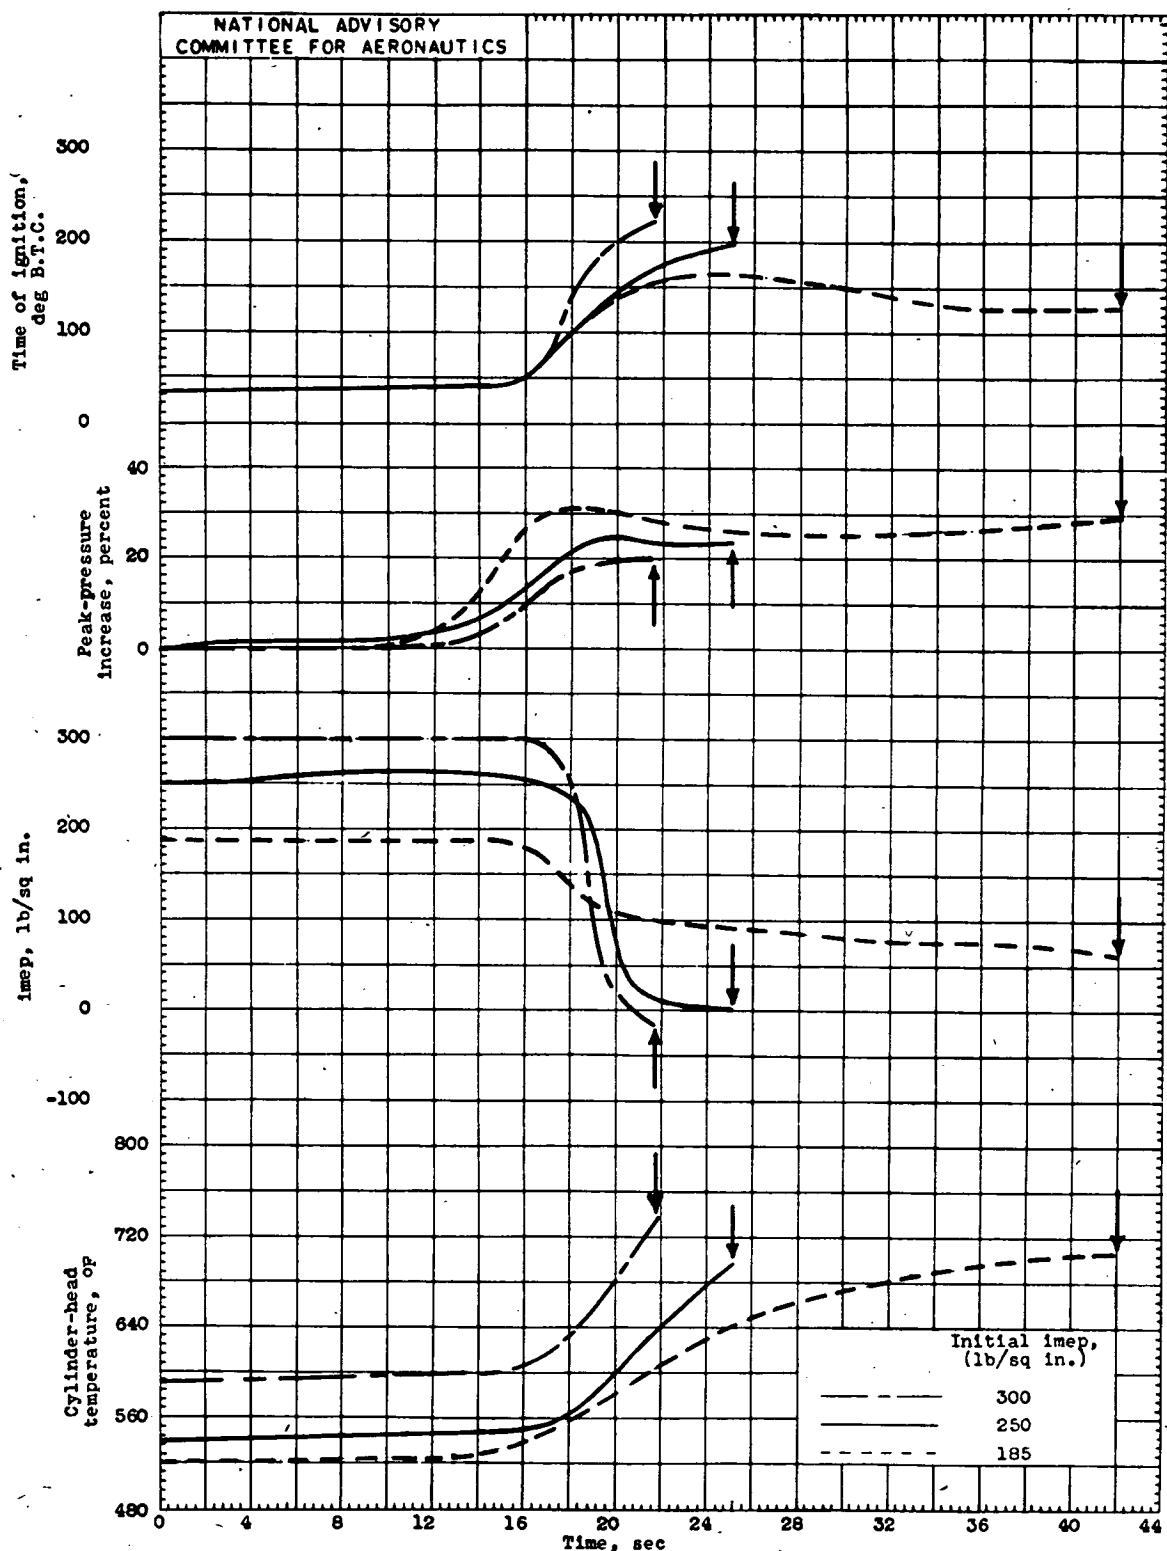
Effect of power output. - Typical preignition runs at three power levels (obtained by using spark plugs of three different heat ranges) are shown in figure 6. The main effect of increased power output was to increase the rapidity with which changes took place. Backfiring terminated all three runs but at the lowest power output a much longer time was required before the backfire occurred. The power output for the lowest initial power runs dropped 65 percent before backfiring occurred and for the two high initial power runs dropped to approximately zero before backfiring took place; the cylinder-head temperature at the time of backfiring was about the same for all three runs. Peak cylinder pressure was increased 20 to 30 percent during preignition with some indication that the percentage increase varied inversely with the power level.

Figure 6. - Effect of initial power output on behavior of engine when preignition is encountered. Engine speed, 3000 rpm; spark advance: inlet, 28° B.T.C.; exhaust, 34° B.T.C.; compression ratio, 6.65; outlet-coolant temperature, 250° F; mixture temperature, 175° F; inlet-oil temperature, 185° F; fuel-air ratio, 0.070; fuel, 30-percent cumene blend; source of preignition, spark plug in exhaust side. (Arrows indicate time of backfire.)

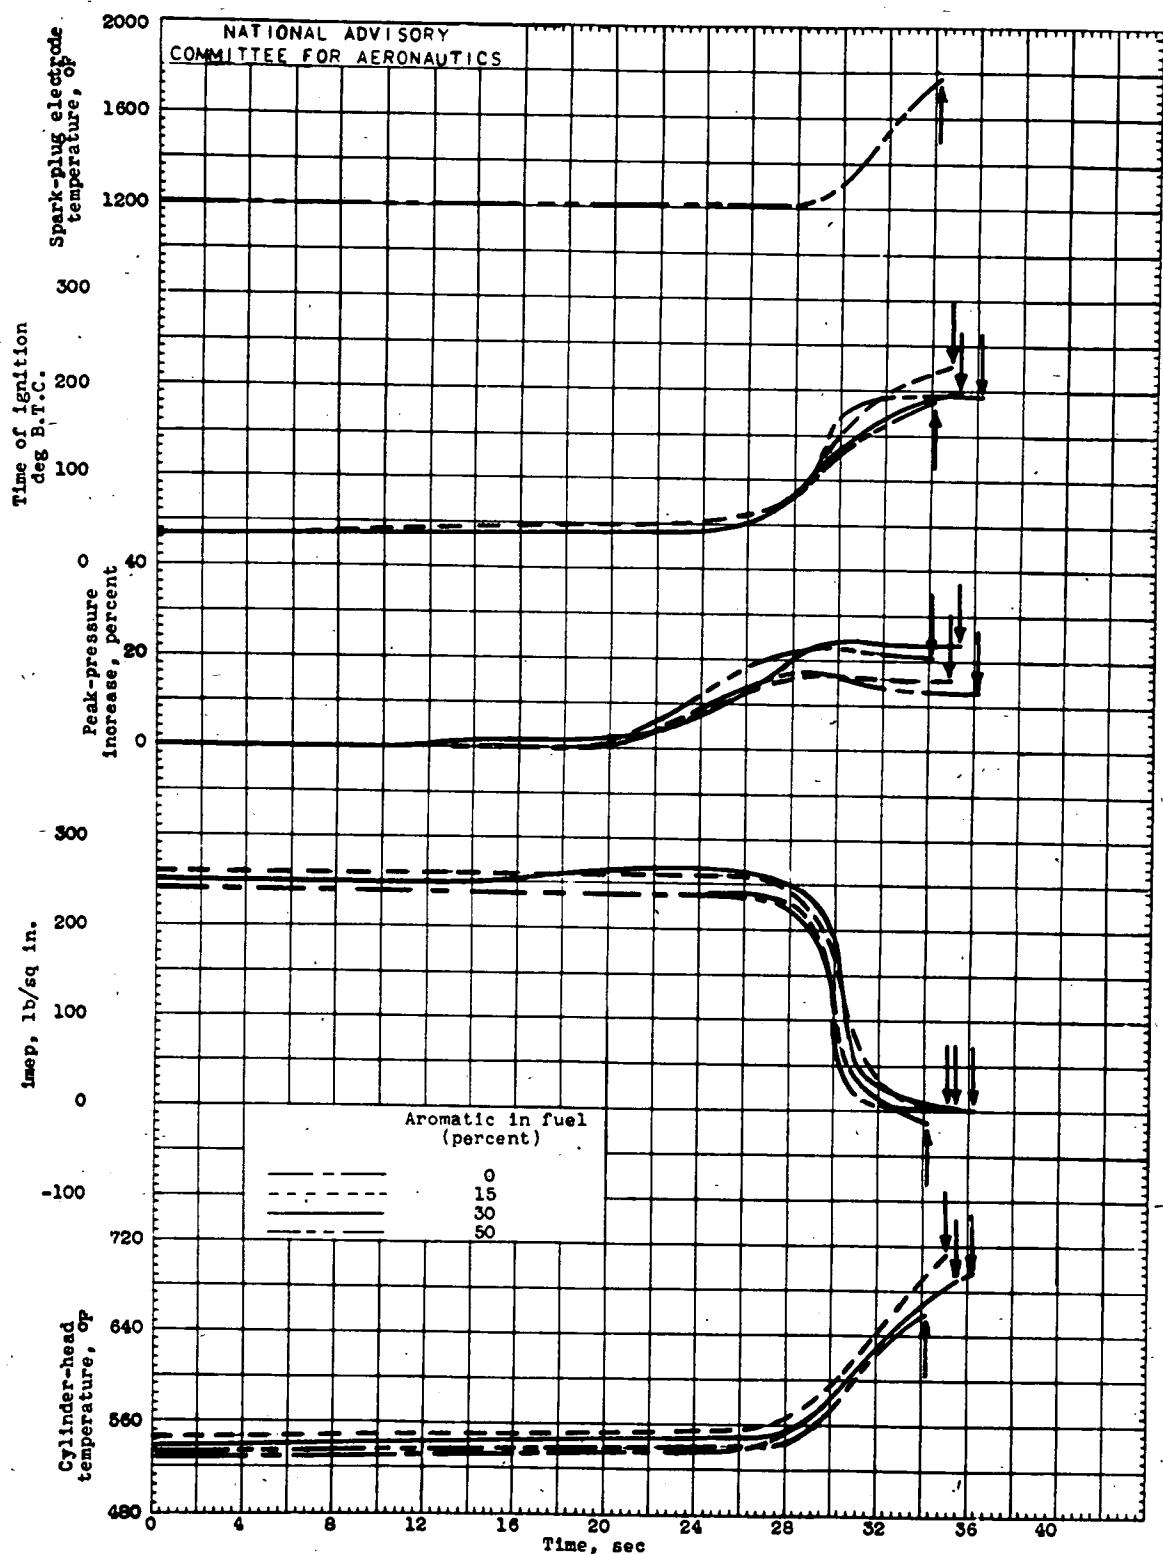
Effect of aromatic content of fuel. - The preignition rating of a fuel depends to a large extent on its aromatic content. However, at the conditions investigated the percentage of aromatics in the fuel had only a small effect on the behavior of the engine after preignition was excited (fig. 7). The peak-pressure-increase curves show the greatest effect with a trend toward a direct relation between aromatic content and peak-pressure increase.

A curve is also included in figure 7 that shows the changes in the temperature of the center electrode of the intake spark plug during a preignition run. This spark plug was of a colder-operating type than that used in the exhaust side as the preignition source. The temperature of this intake plug increased approximately 550° F before backfiring was encountered. Because of difficulties involved in obtaining measurements of this temperature, the data shown are the only data available.

Figure 7. - Effect of aromatic content of fuels on behavior of engine after preignition is encountered. Engine speed, 3000 rpm; spark advance: inlet, 28° B.T.C.; exhaust, 34° B.T.C.; compression ratio, 6.65; outlet-coolant temperature, 250° F; mixture temperature, 175° F; inlet-oil temperature, 185° F; fuel-air ratio, 0.070; source of preignition, spark plug in exhaust side. (Arrows indicate time of backfire.)

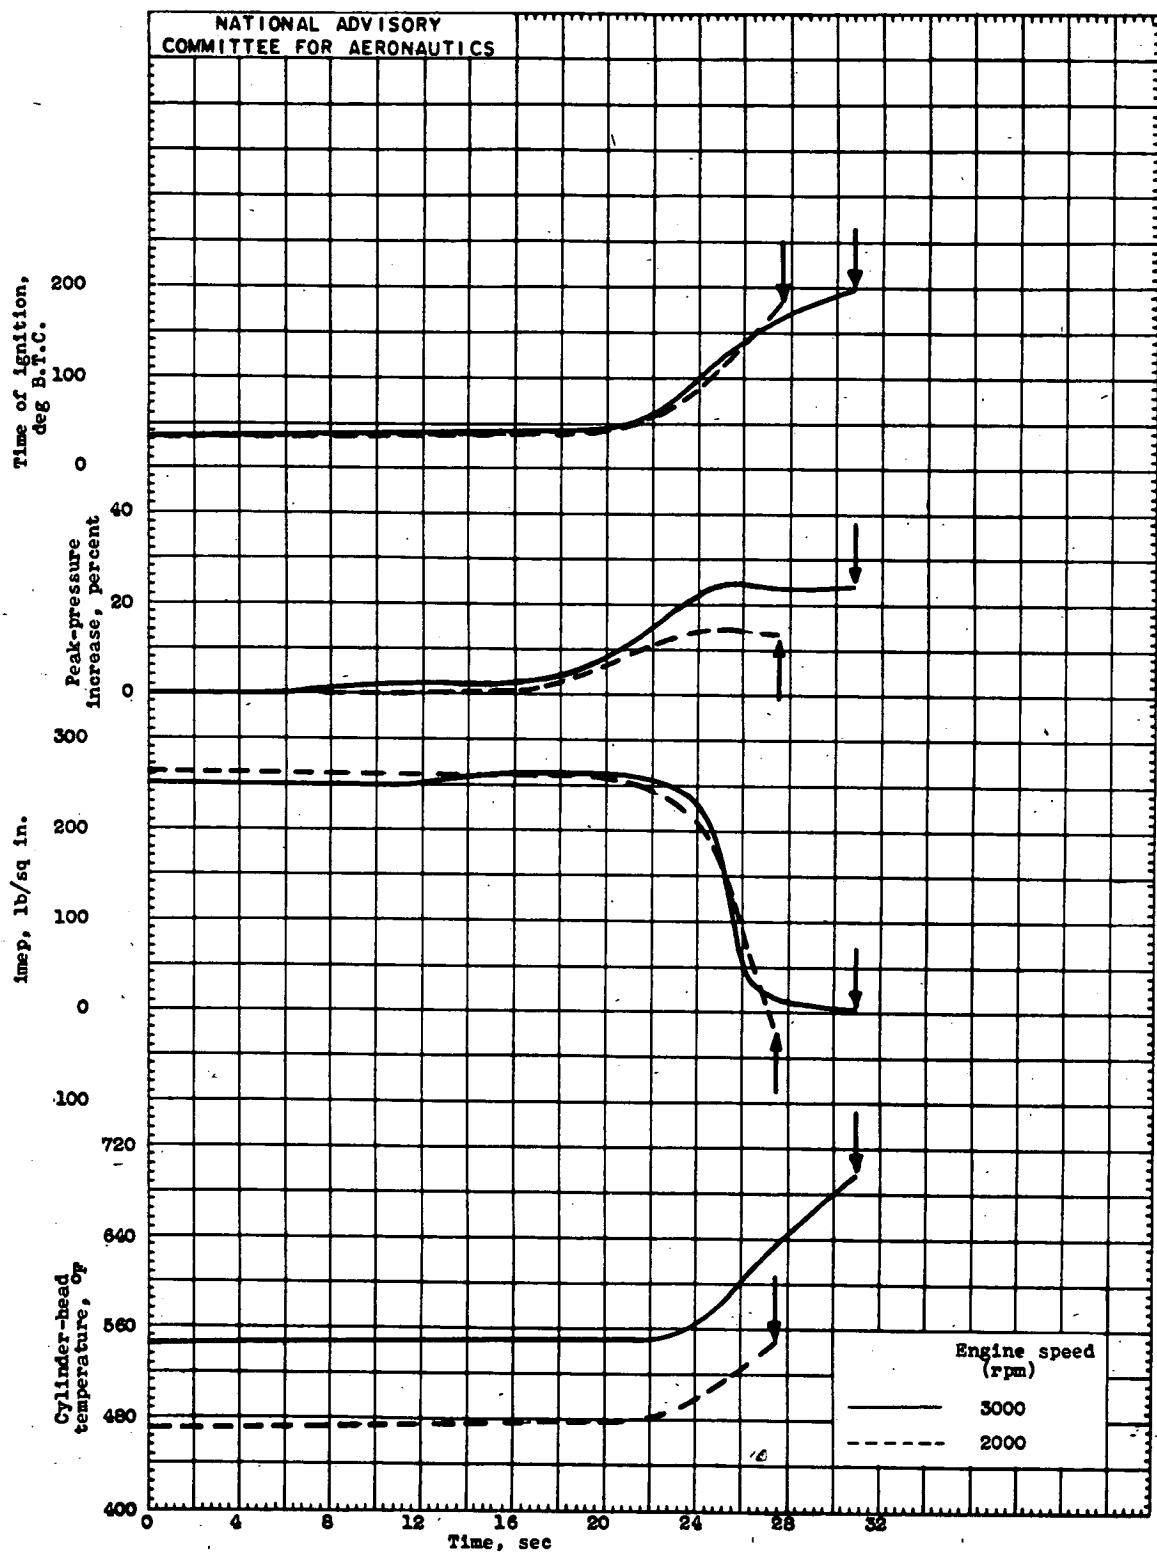
Figure 8. - Effect of engine speed on behavior of engine when preignition is encountered. Spark advance: inlet, 28° B.T.C.; exhaust, 34° B.T.C.; compression ratio, 6.65; outlet-coolant temperature, 280° F; mixture temperature, 175° F; inlet-oil temperature, 185° F; fuel-air ratio, 0.070; fuel, 30-percent cumene blend; source of preignition, spark plug in exhaust side. (Arrows indicate time of backfire.)

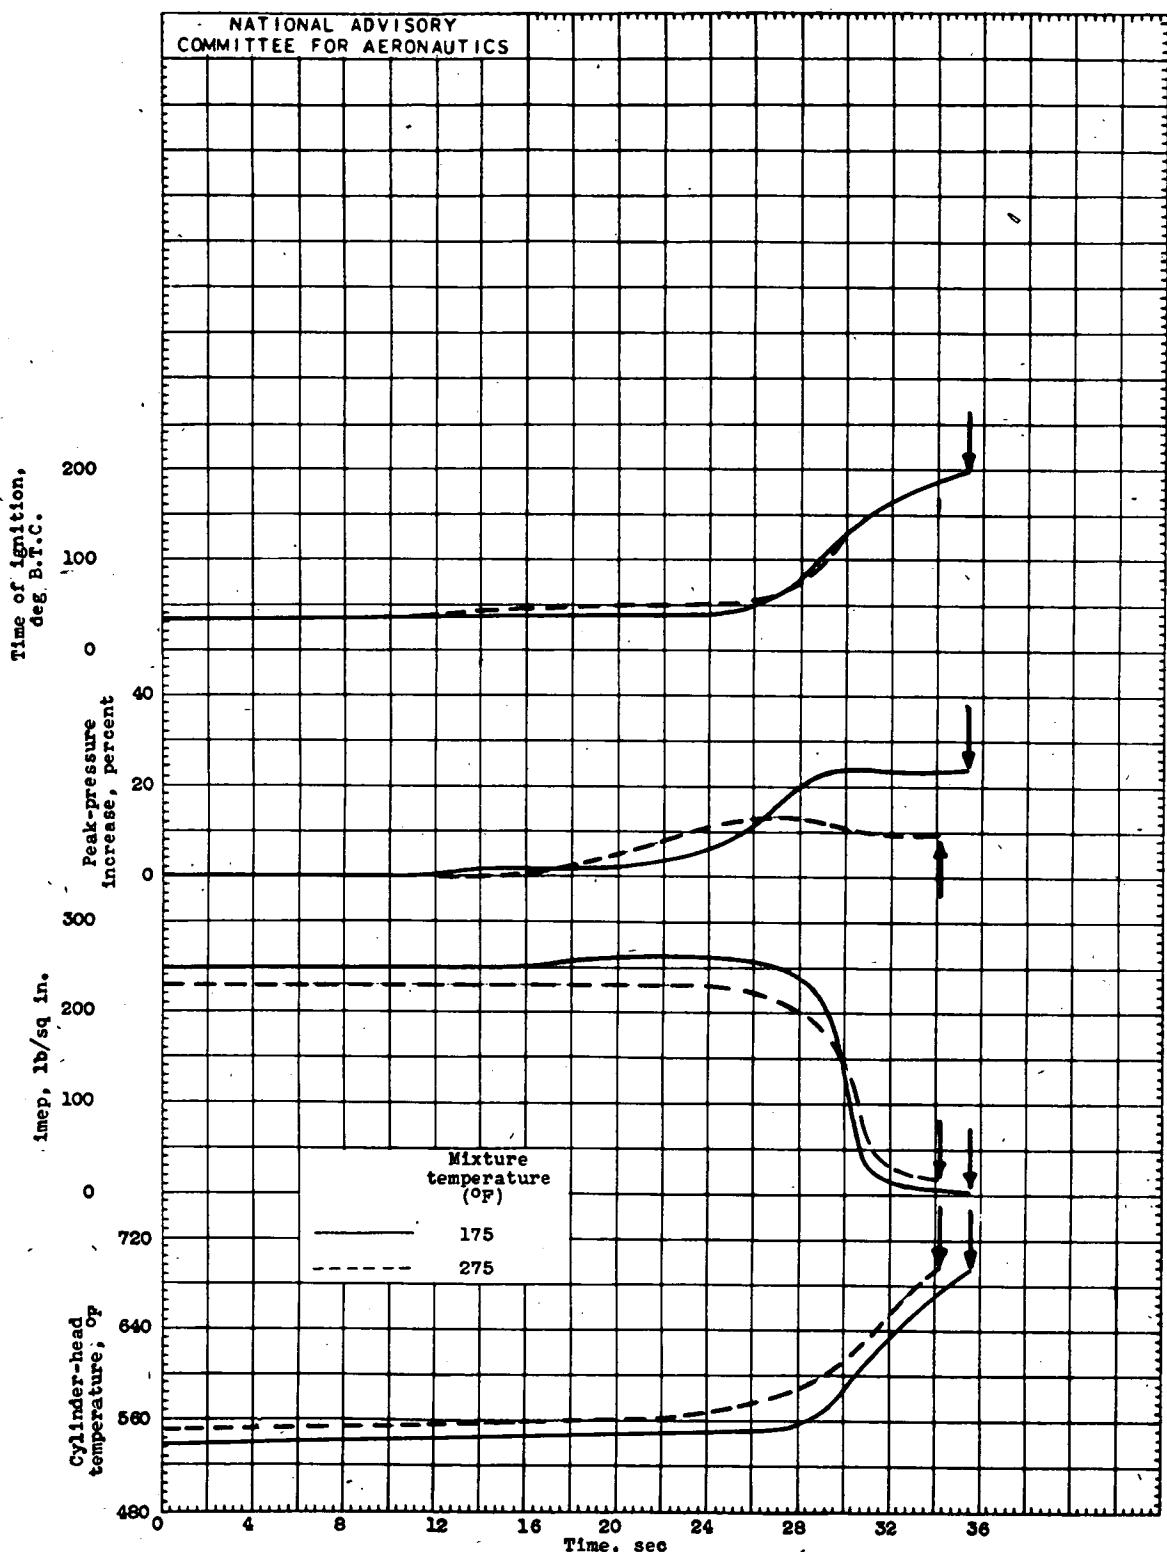
Figure 9. - Effect of mixture temperature on behavior of engine when preignition is encountered. Engine speed, 3000 rpm; spark advance: inlet, 28° B.T.C.; exhaust, 34° B.T.C.; compression ratio, 6.65; outlet-coolant temperature, 250° F; inlet-oil temperature, 185° F; fuel-air ratio, 0.070; fuel, 30-percent cumene blend; source of preignition, spark plug in exhaust side. (Arrows indicate time of backfire.)

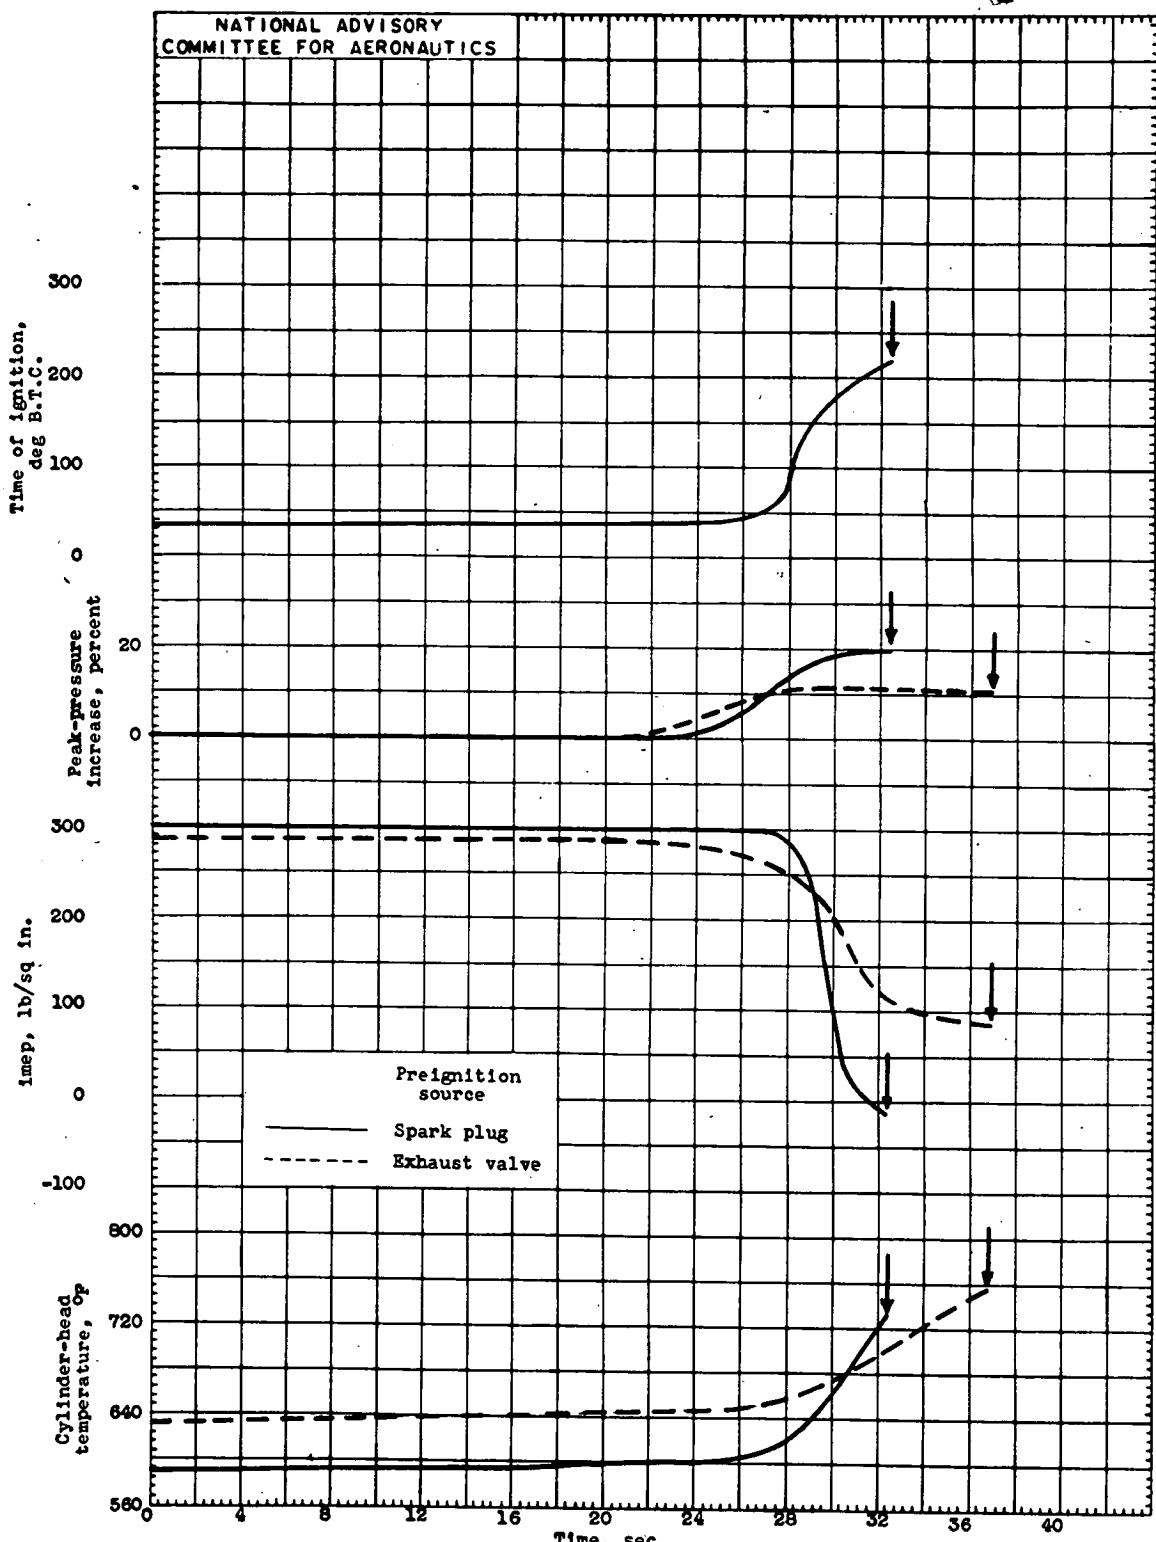
Figure 10. - Effect of preignition source on behavior of engine when preignition is encountered. Engine speed, 3000 rpm; spark advance: inlet, 28° B.T.C.; exhaust, 34° B.T.C.; compression ratio, 6.65; outlet-coolant temperature, 250° F; mixture temperature, 175° F; inlet-oil temperature, 185° F; fuel-air ratio, 0.070; fuel, 30-percent cumene blend. (Arrows indicate time of backfire.)

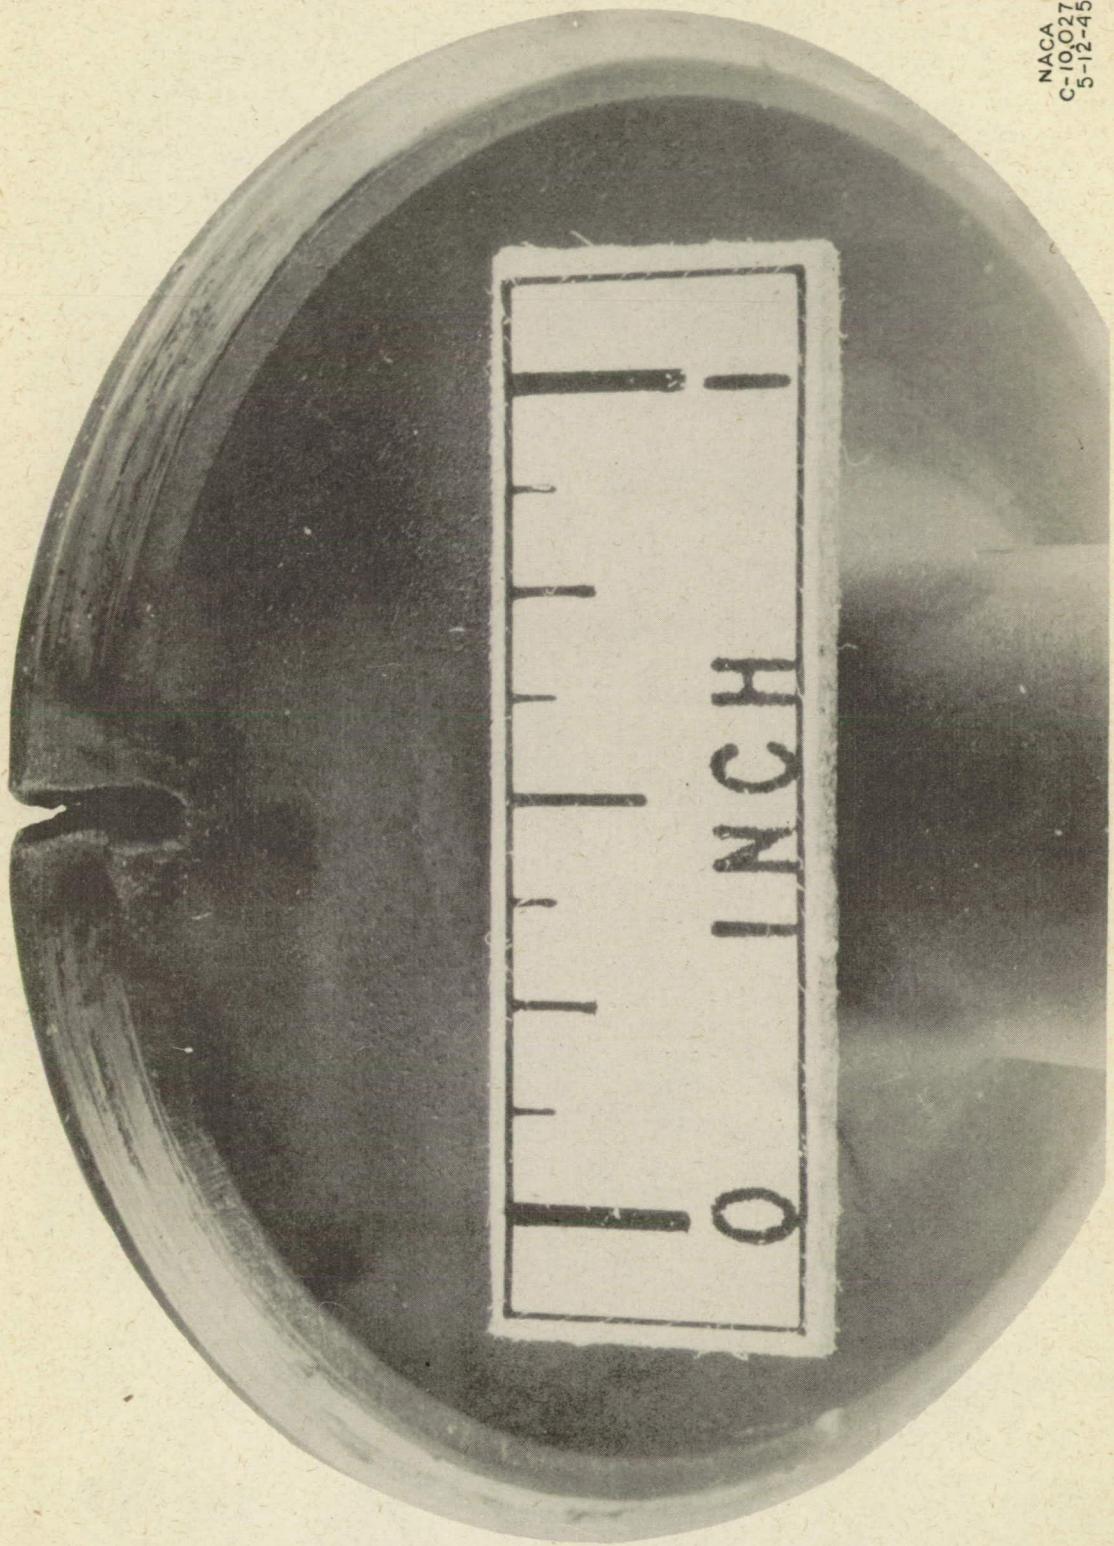
Fig. II

Engine difficulties experienced. - The previously mentioned runs were made with a stock piston, the diameter of which had been reduced 0.005 inch. With this added piston clearance, the only part failures encountered involved the spark plugs and the intake valves. After engine operation under some of the preignition conditions, the center electrode of the exhaust spark plug was found to be burned or melted. On two occasions one of the intake valves was found to be burned (fig. 11). Although piston-ring wear was more rapid than normal, no other failures were experienced in more than 500 preignition runs of the type discussed.

Figure II. - Intake valve burned during preignition runs.

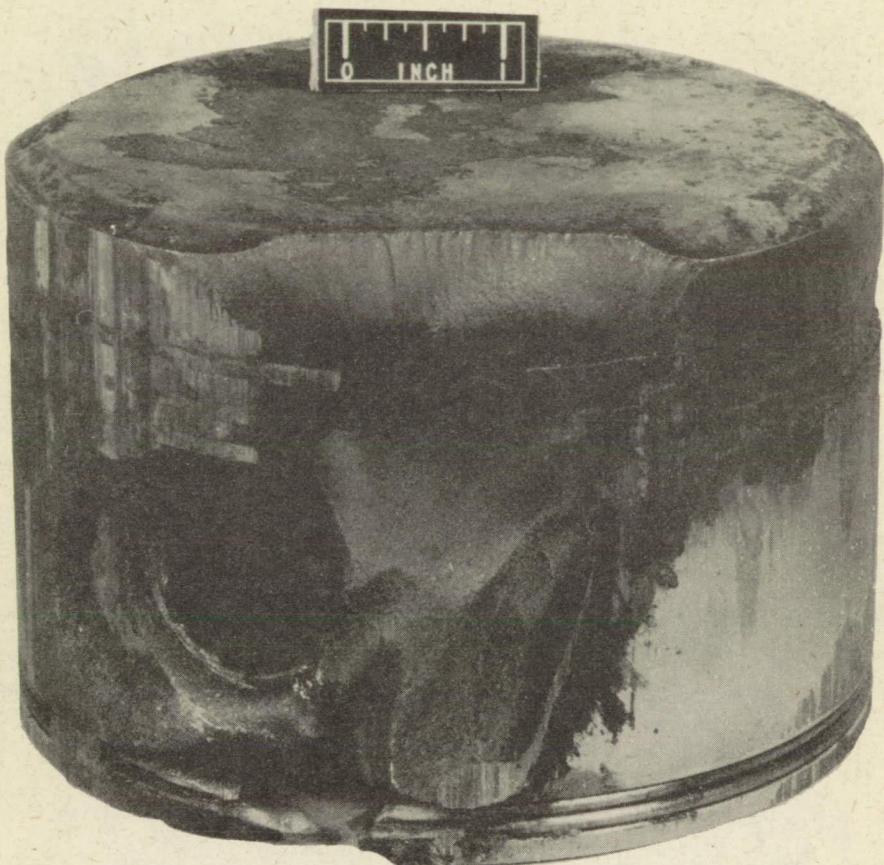
Fig. 12a

The clearance for the first run was about 0.004 inch less than the normal value (0.021 in.) for the engine. In this run preignition caused overheating that resulted in piston seizure and consequent melting of the side (fig. 12(a)). With the normal clearance, a higher power level was necessary to cause failure but the failure was of the same nature (fig. 12(b)). The general temperature level of the piston at the time of seizure was apparently higher, however, and a small amount of local melting took place in the center of the crown. When the clearance was increased to 0.005 inch greater than normal, the failure was still a seizure with consequent melting of the side (fig. 12(c)) but more local melting took place in the center of the crown than with normal clearance. A further increase of the clearance to 0.013 inch greater than normal eliminated the seizure (fig. 12(d)) and complete failure was not experienced at the power level tested. Slightly more severe local melting, however, took place in the center of the crown. On the basis of these runs and a number of unreported preignition investigations, it is believed that when piston failure is caused by preignition the type of failure depends mainly on the clearance between the piston and the cylinder. With small clearances, the failure occurs through seizure and consequent melting of the side; whereas if the clearances are large enough, it is believed that melting will occur wherever the piston is hottest, in the center of the crown in this instance.

(a) Clearance, 0.004-inch less than normal; imep, 271 pounds per square inch; fuel-air ratio, 0.098.

Figure 12. - Exhaust-side view of piston failures caused by preignition with various clearances between top of skirt and cylinder barrel.

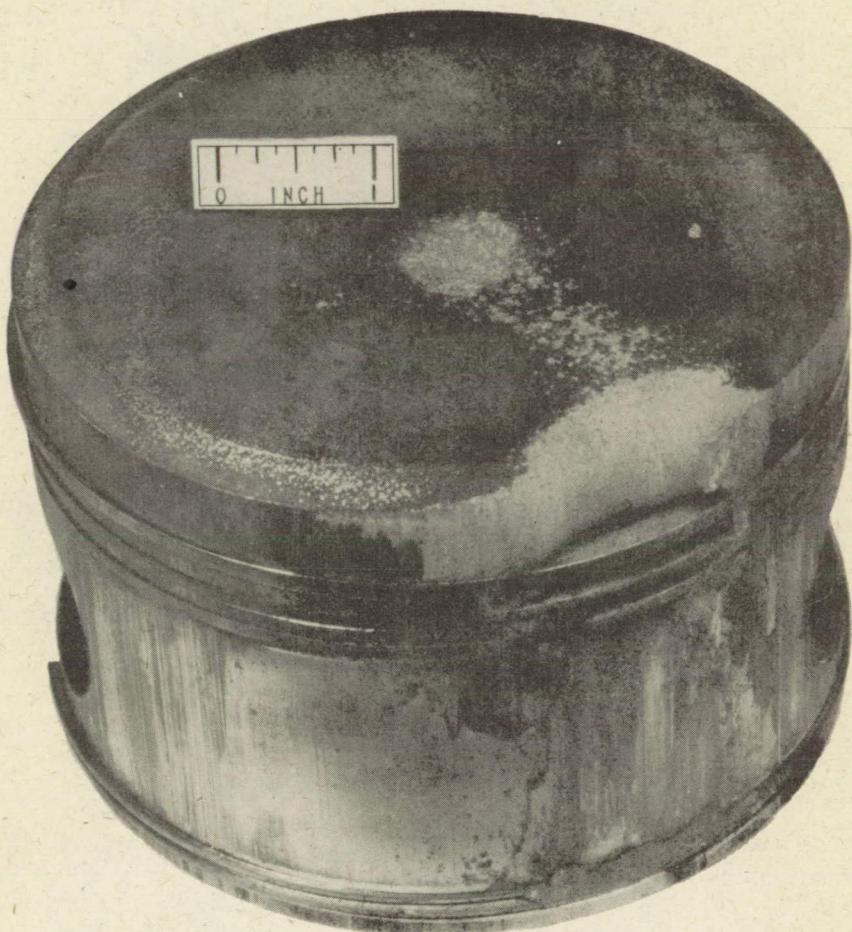
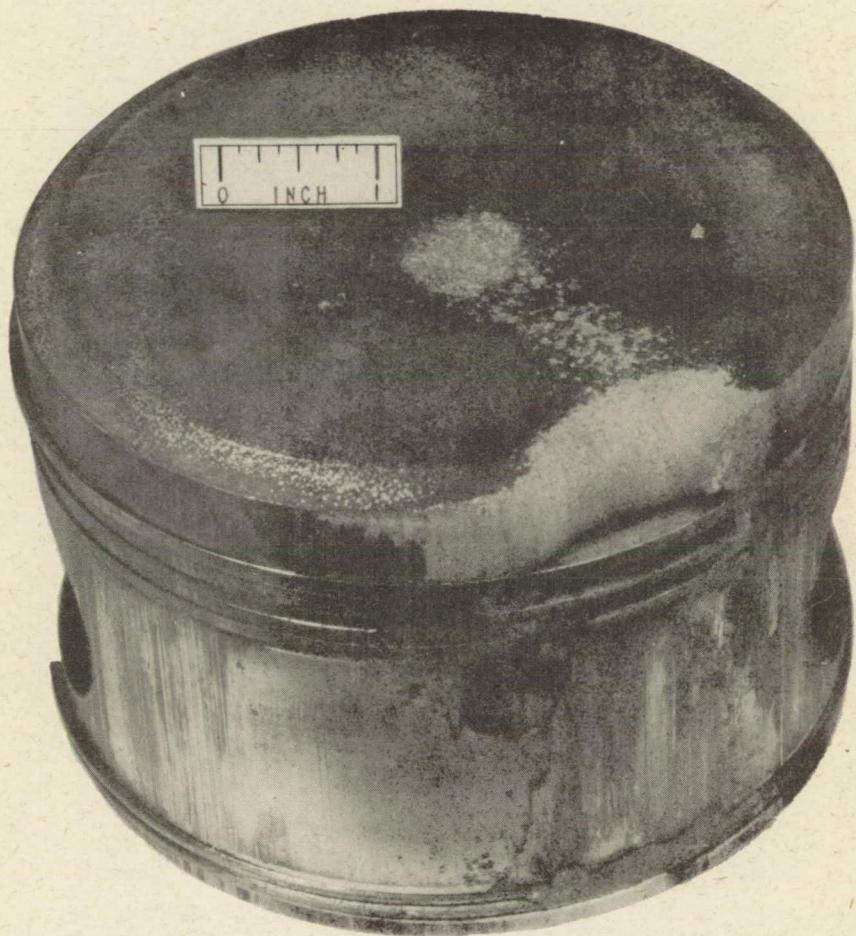
Fig. 12b

(b) Clearance, normal; imep, 364 pounds per square inch;
fuel-air ratio, 0.094.

Figure 12. - Continued. Exhaust-side view of piston failures
caused by preignition with various clearances between top
of skirt and cylinder barrel.

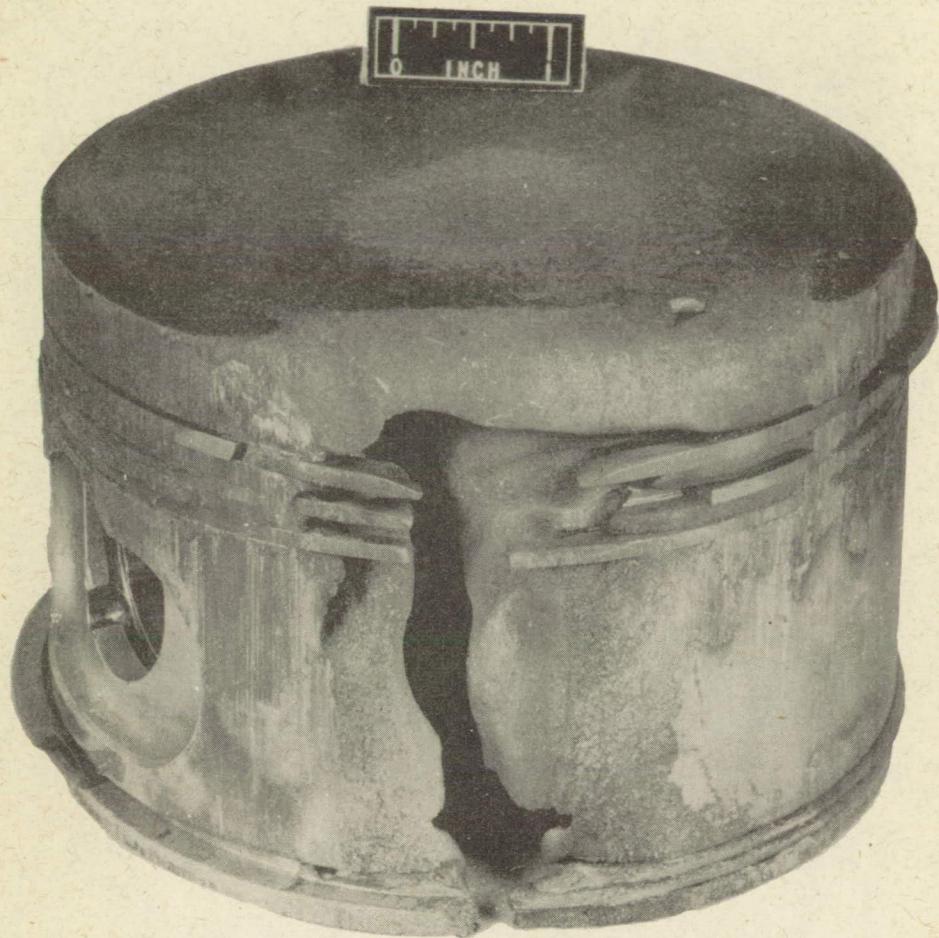
Fig. 12c

(c) Clearance, 0.005-inch greater than normal; imep, 364 pounds per square inch; fuel-air ratio, 0.094.

Figure 12. - Continued. Exhaust-side view of piston failures caused by preignition with various clearances between top of skirt and cylinder barrel.

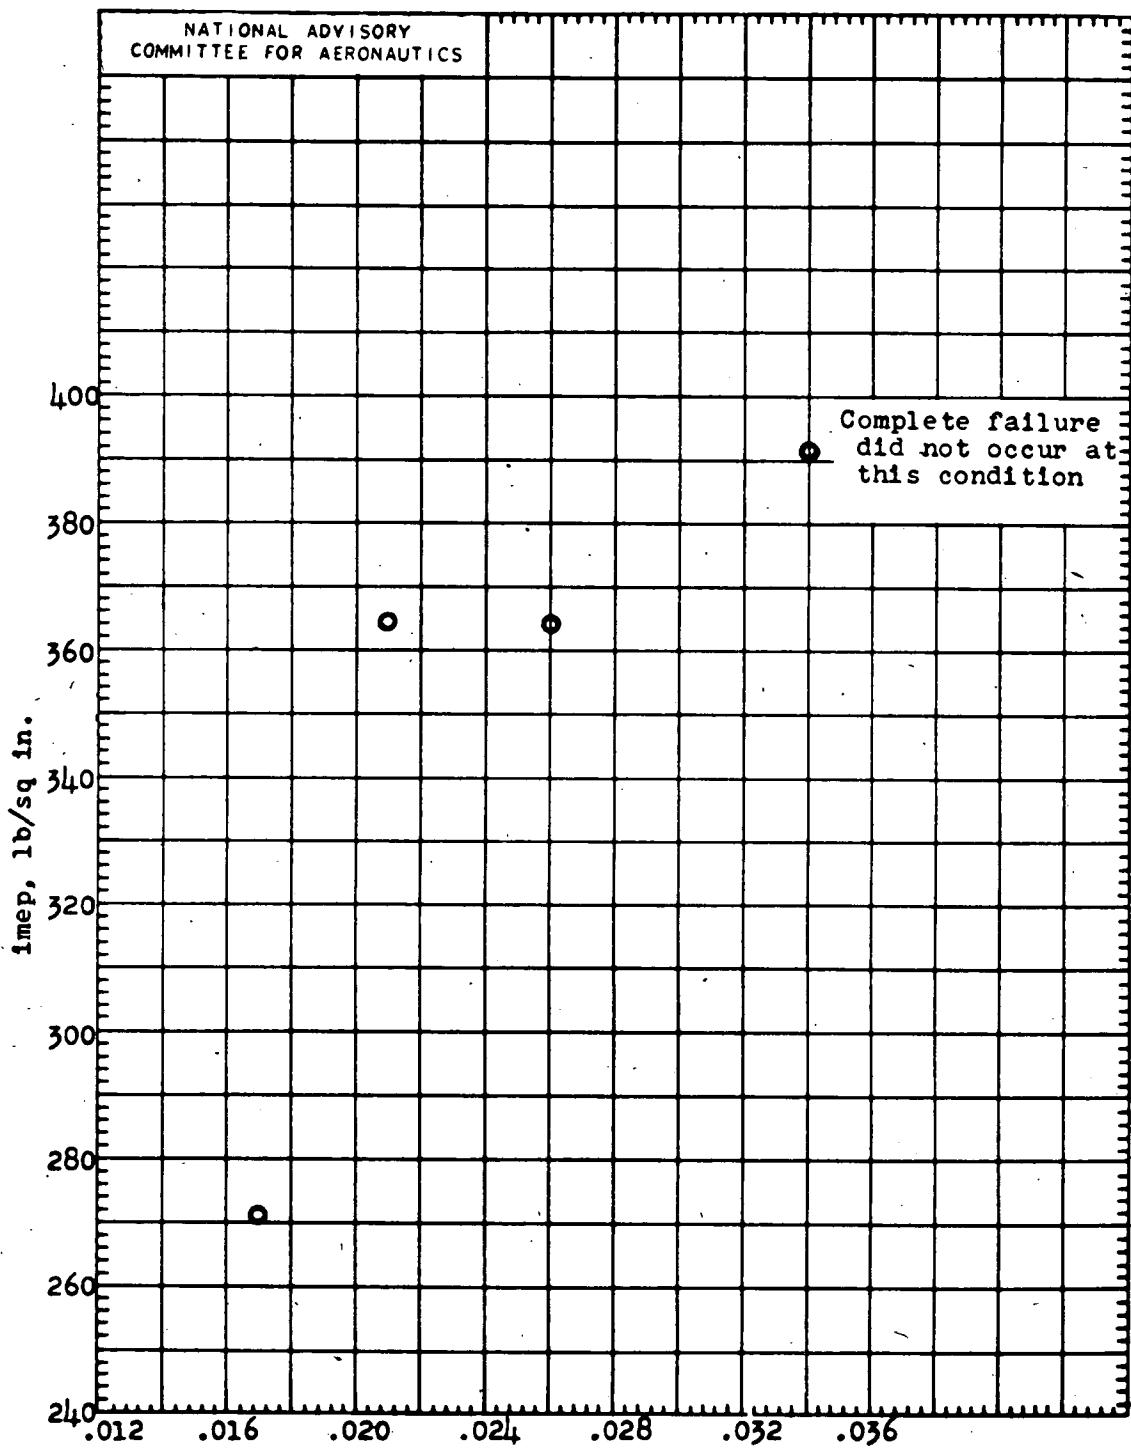
Destruction tests with different clearances between the piston and the cylinder barrel indicated that with normal clearance preignition caused overheating that resulted in overexpansion of the piston, seizure of the piston in the cylinder barrel, and consequent melting

Figure 13.- Effect of piston clearance (measured between top of piston skirt and cylinder barrel) on indicated mean effective pressure necessary to cause piston seizure when preignition is encountered.
